TECHNICAL SERVICE BULLETIN

Water Leak Into Liftgate - Built On Or Before 29-Sep-2023

23-2360
16 November
2023

Ford 2021-2023 Mustang Mach-E	Built on or before 29-Sep-2023
---	--------------------------------

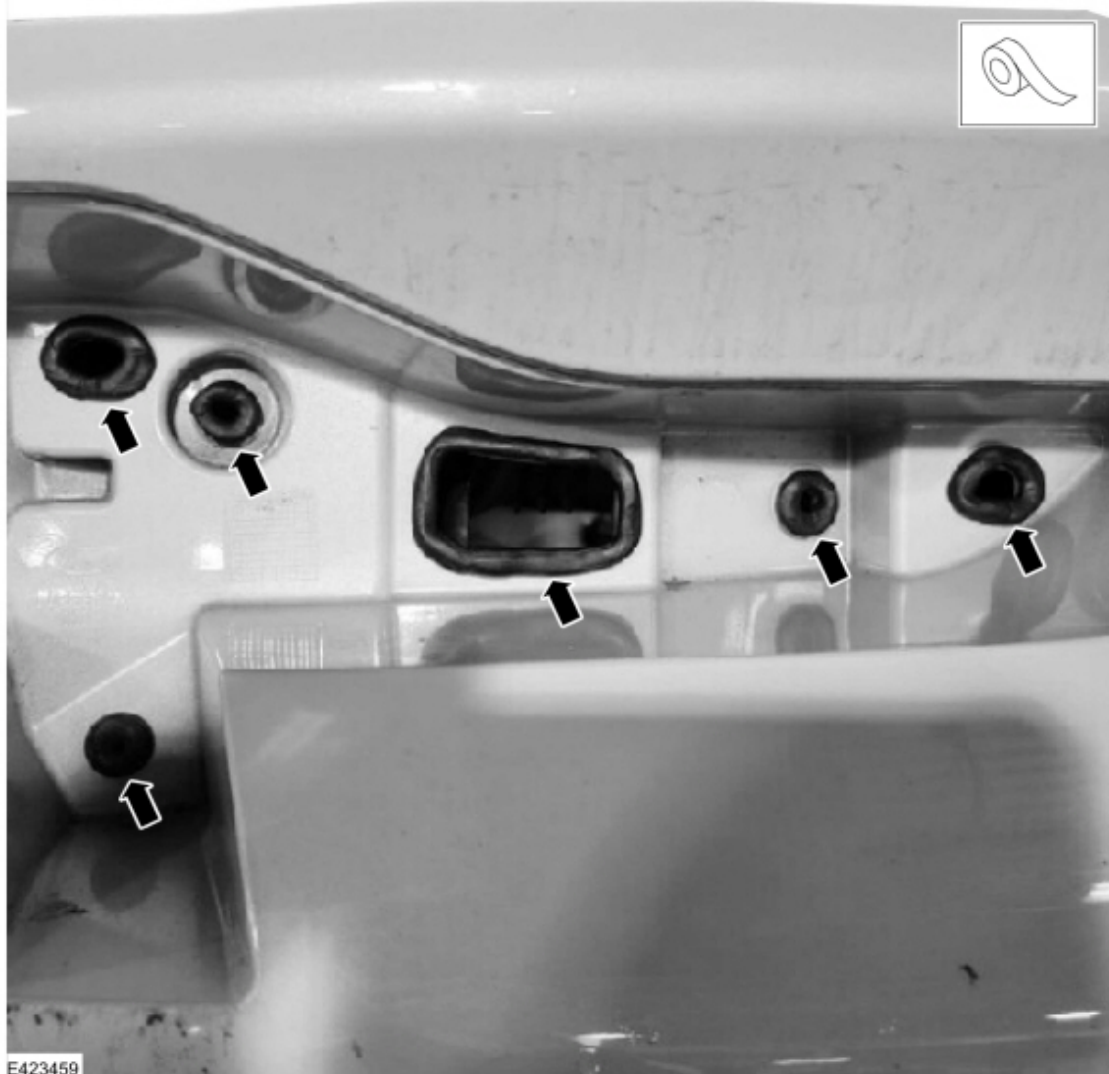
Figure 1

Issue: Some 2021-2023 Mustang Mach-E vehicles built on or before 29-Sep-2023 may experience a water leak into the liftgate. This may be due to water intruding past the seals on the liftgate mounted rear lamp assemblies. To correct the condition, follow the Service Procedure to seal the lamp cavities.

4. Using butyl sealant tape, create a bead around each cavity of both liftgate mounted rear lamps as shown in Figures 1-2.
